# **Mercury Five Islands Fountain**

## **Refurbishment Assessment**

Wollongong Botanic Gardens  
Murphys Avenue Keiraville NSW  
34°24' 32"S 150°52'38"E

31 August 2017

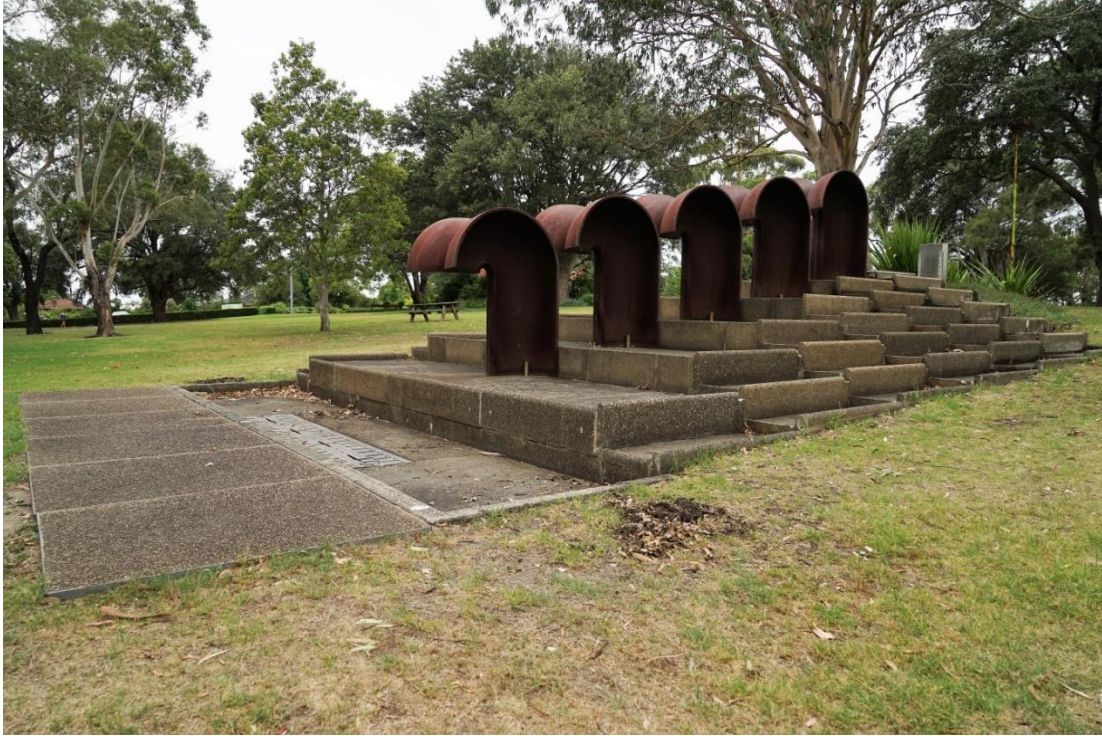
A1: View from the northwest. The additional tank is under the concrete slabs on the left.

Install one new tank of 6000 litres to replace the current two tanks. This would not only reduce water consumption and simplify maintenance but also ensure the water level is well above the pump intake during operation.

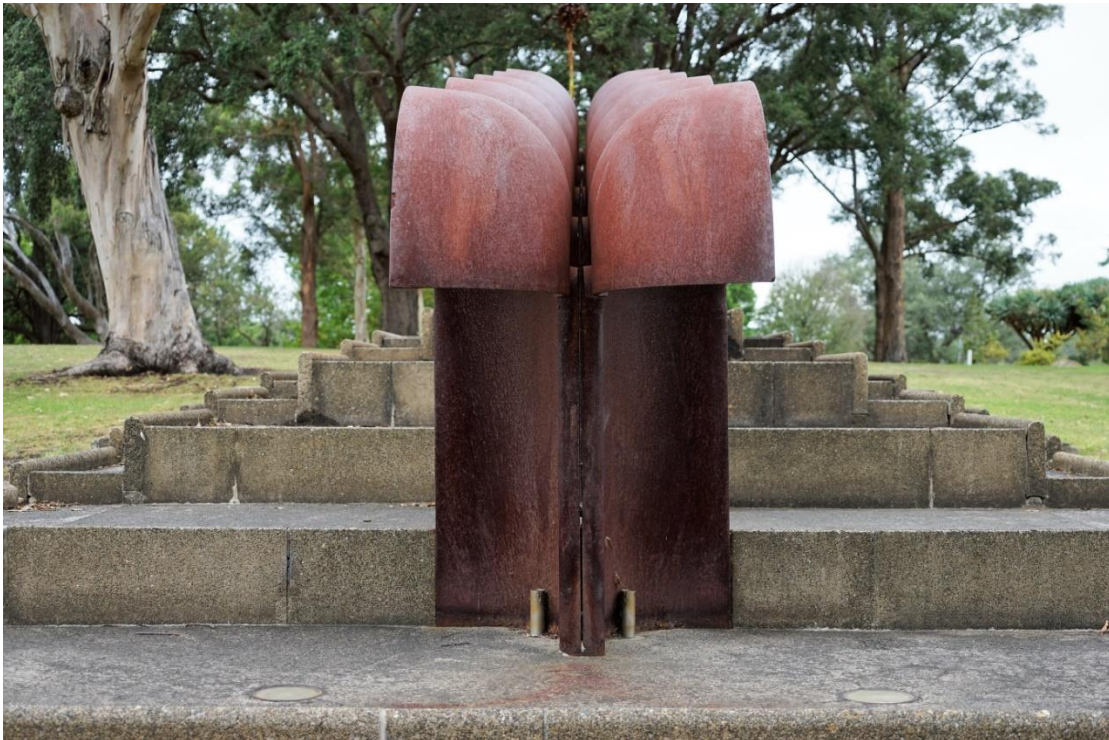
The ten half-pipes and nozzles are in good condition with a patina of rust evenly covering the half-pipe exposed surfaces.

A2: View from the north showing the nozzles and half pipes bracketed by the main weirs.

No work is needed on the half-pipes or nozzles.

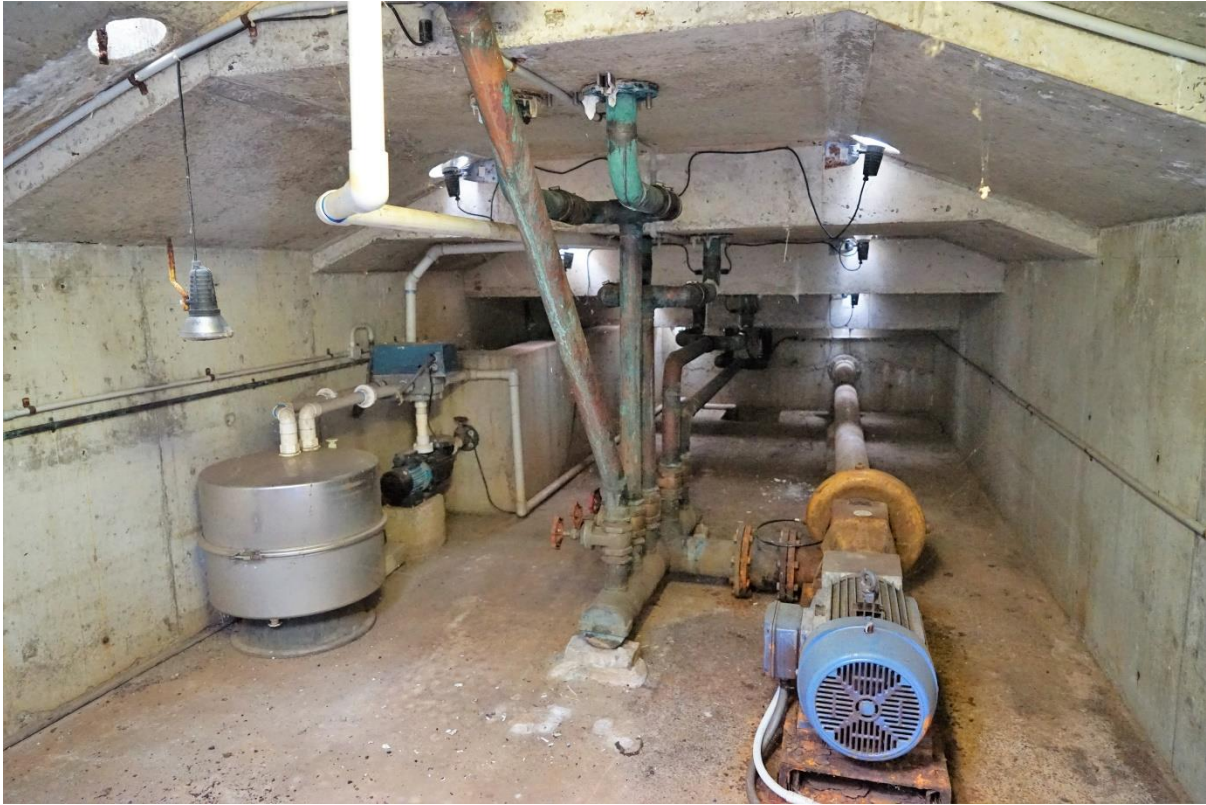
There are currently two tanks. This resulted from the non-optimal fountain installation in WBG and has resulted in an ineffective tank system where the water level is not always above the pump intake during operation.

There is evidence of considerable leakage into the plant room. This is understood to be a result of the failed waterproofing in the pools above.

C1: Plant room from the base of the access ladder. The main tank is at the far end. Filtering tank on the left.

Check for leaks in the plant room. This should be undertaken at the commencement and conclusion of the refurbishment. Pool waterproofing is expected to reduce current leakages.

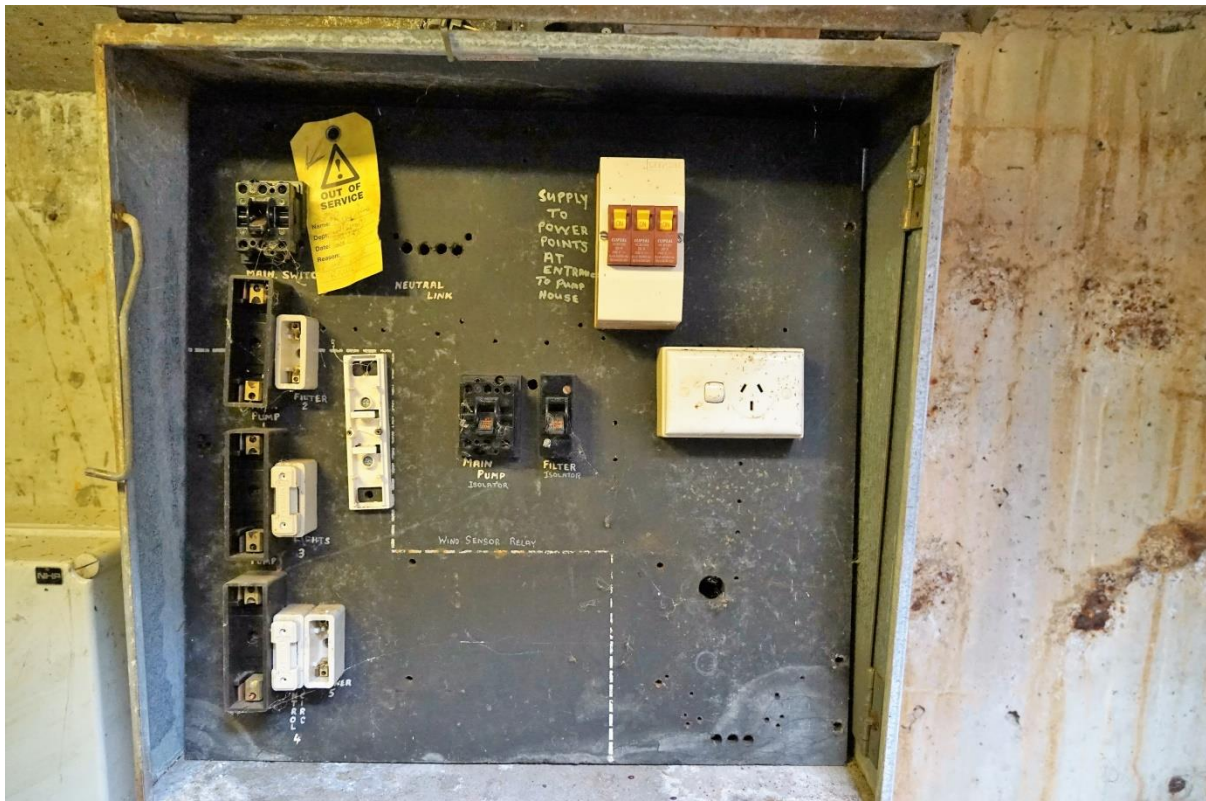
The current switchboard location visually intrudes on the fountain and negatively impacts the original design intent.

C2: Main switchboard in plant room

Switchboard relocation and replacement, anemometer installation, and associated works.
